Spanish Fork, Utah  
May 20, 1960

*Re: Spanish Fork.*

The following is an account of the information you requested on Floyd Gardner.

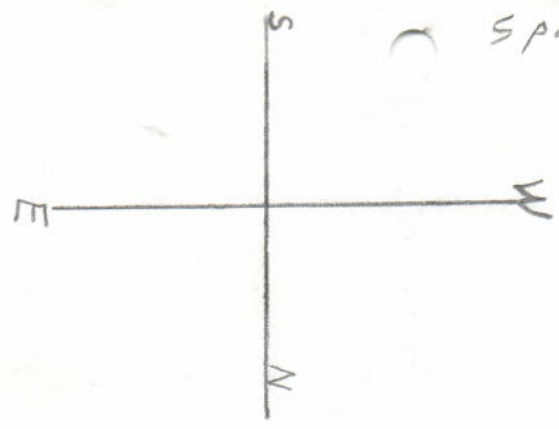
Spanville Fork.

Mr. Floyd Gardner claims all seepage water and waste water from pasture land and high ground below upper Mitchell Ditch. (Shaded in yellow on sketch)

In July of 1959 Mr. Gardner put in about a 12" pipe flume to carry the seepage and waste water across Rock Hollow Creek and into the Knoll Ditch and onto his farm.

On May 19, 1960 Mr. Orla Stewart and myself found a large section of the upper Mitchell Ditch broken out so that Mr. Gardner was getting about one c.f.s. of water through the pipe flume he constructed.

WHERE SECTION OF DITCH WAS BROKEN OUT MAY 19, 1960

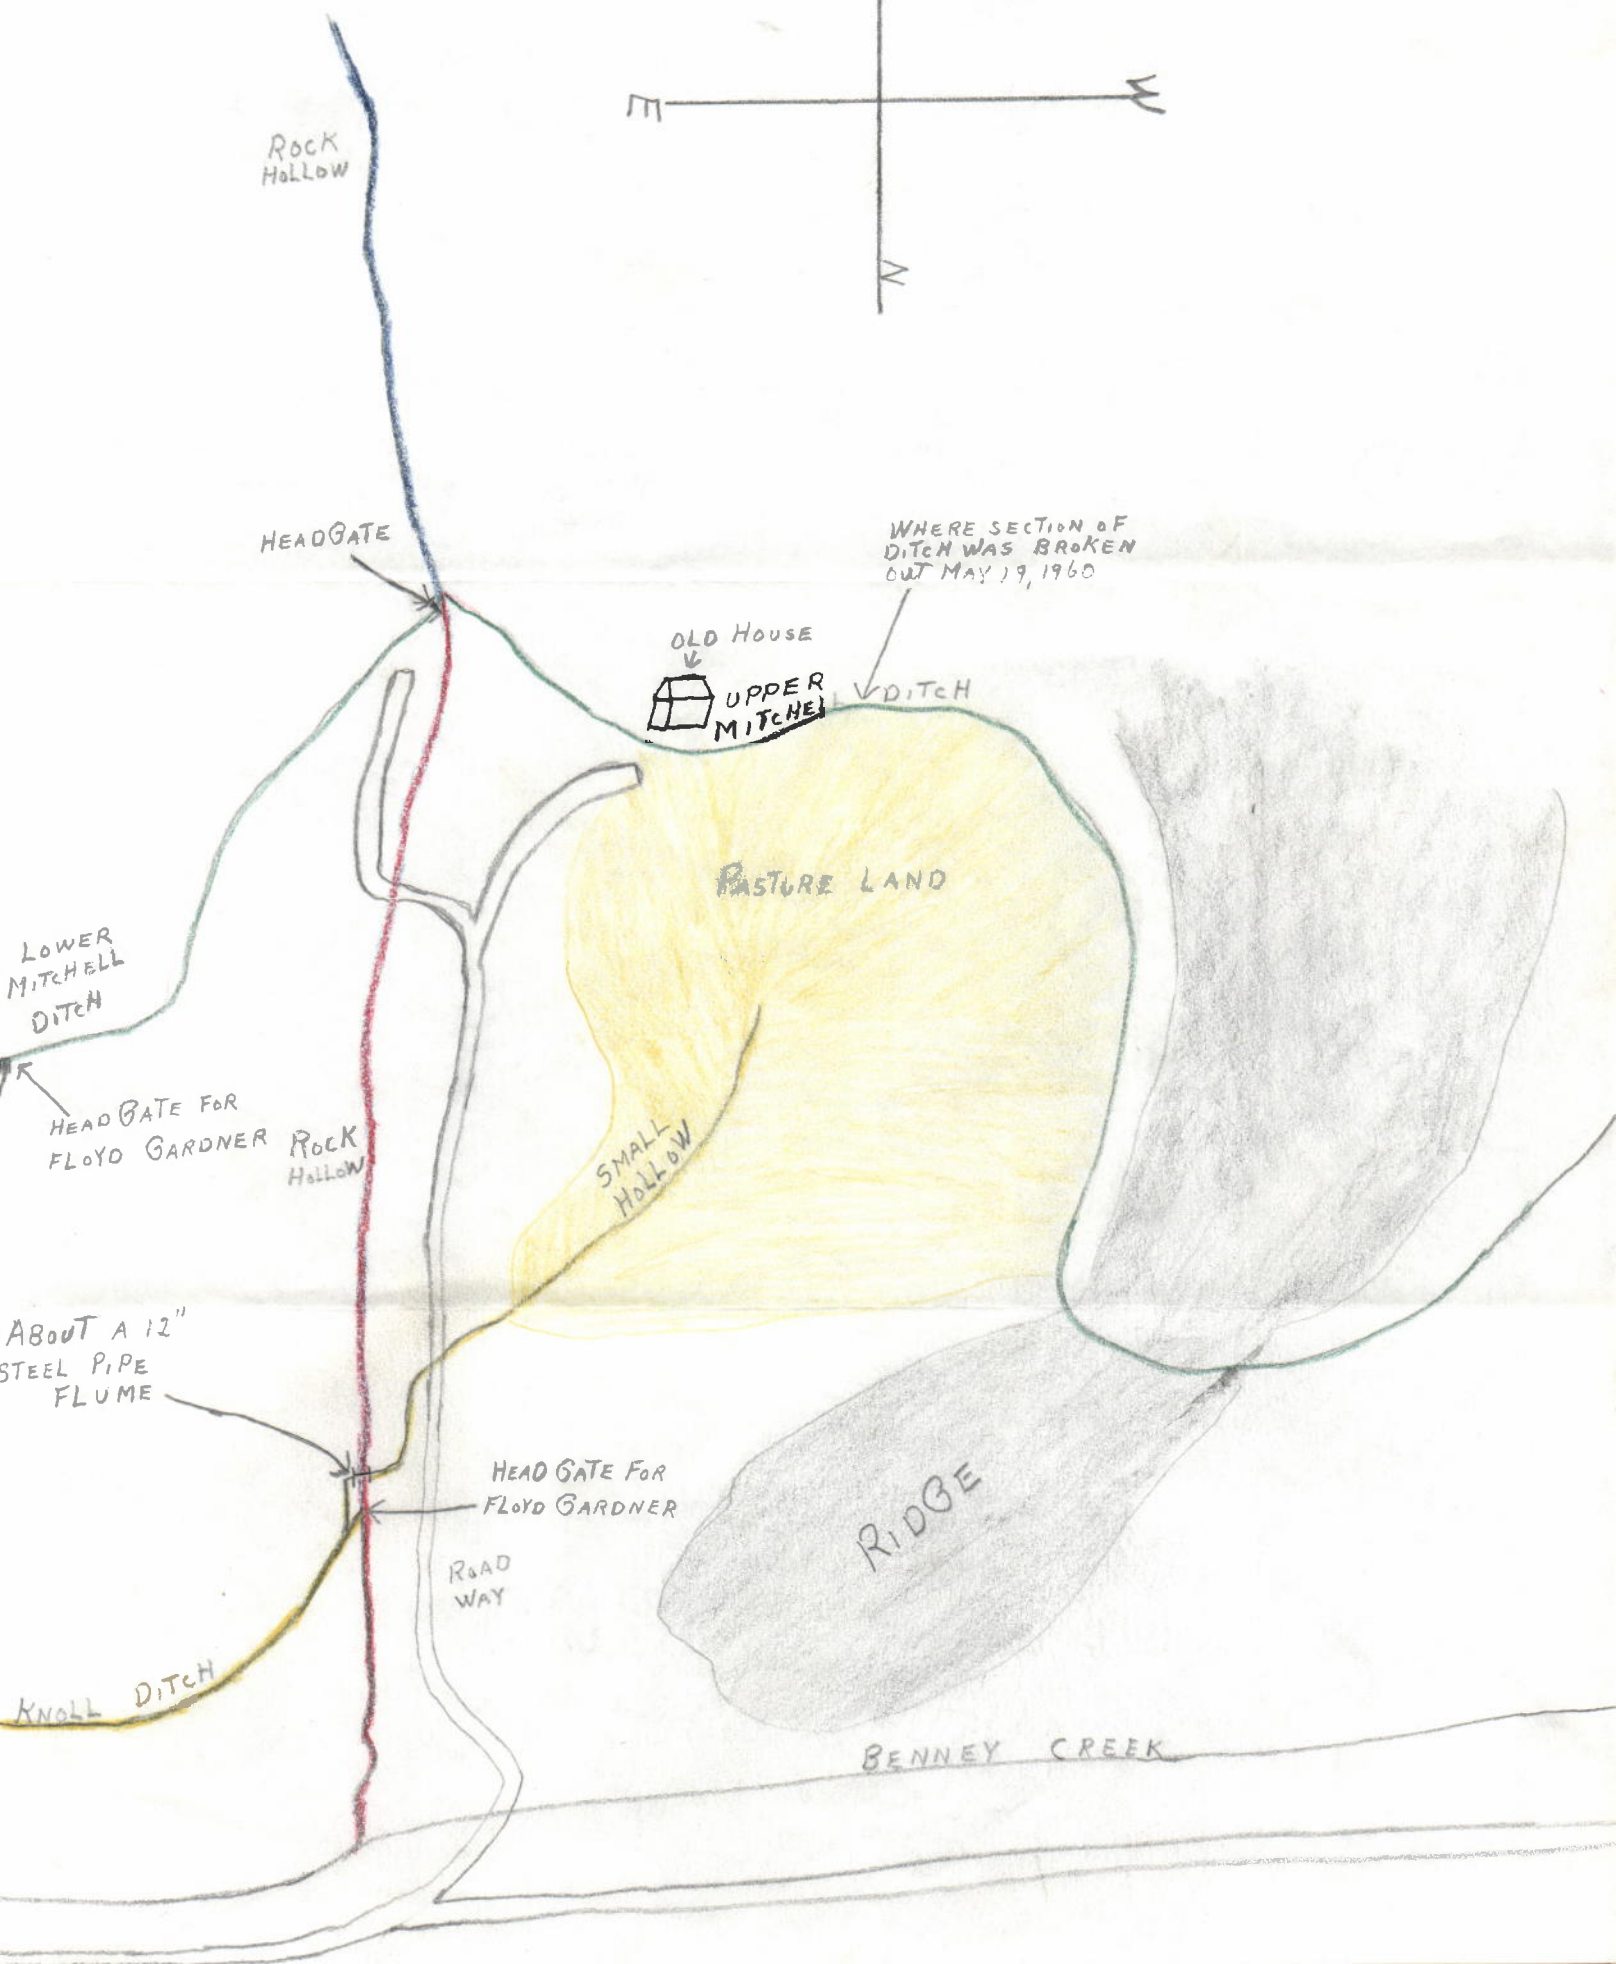
HEADGATE FOR FLOYD GARDNER

ABOUT A 12" STEEL PIPE FLUME

Mr. Stewart and myself are continually tamping sod and dirt around the Gardner headgate on the Rock Hollow, but for some reason not understandable to us it keeps leaking.

On May 18, 1960 Mr. Stewart turned 1/10 of a c.f.s. into the lower Mitchell Ditch for watering sheep grazing on Mrs. Poulsens ground. (She recieved a charge for this water.) On the morning of May 19, 1960 when the shepherd checked the water, it was diverted at Mr. Gardners headgate onto his farm on the lower Mitchell Ditch. Mr. Gardner says he doesn't know anything about this.
